SECTION 32 PROGRAM
STREAMBANK EROSION CONTROL
EVALUATION AND DEMONSTRATION
WORK UNIT 2-EVALUATION OF EXISTING
BANK PROTECTION

FIELD INSPECTION OF THE MILL CREEK
MIDFLOODWAY GABION BARRIER IN THE
LOS ANGELES DISTRICT

April 1980
Inspection Report 9

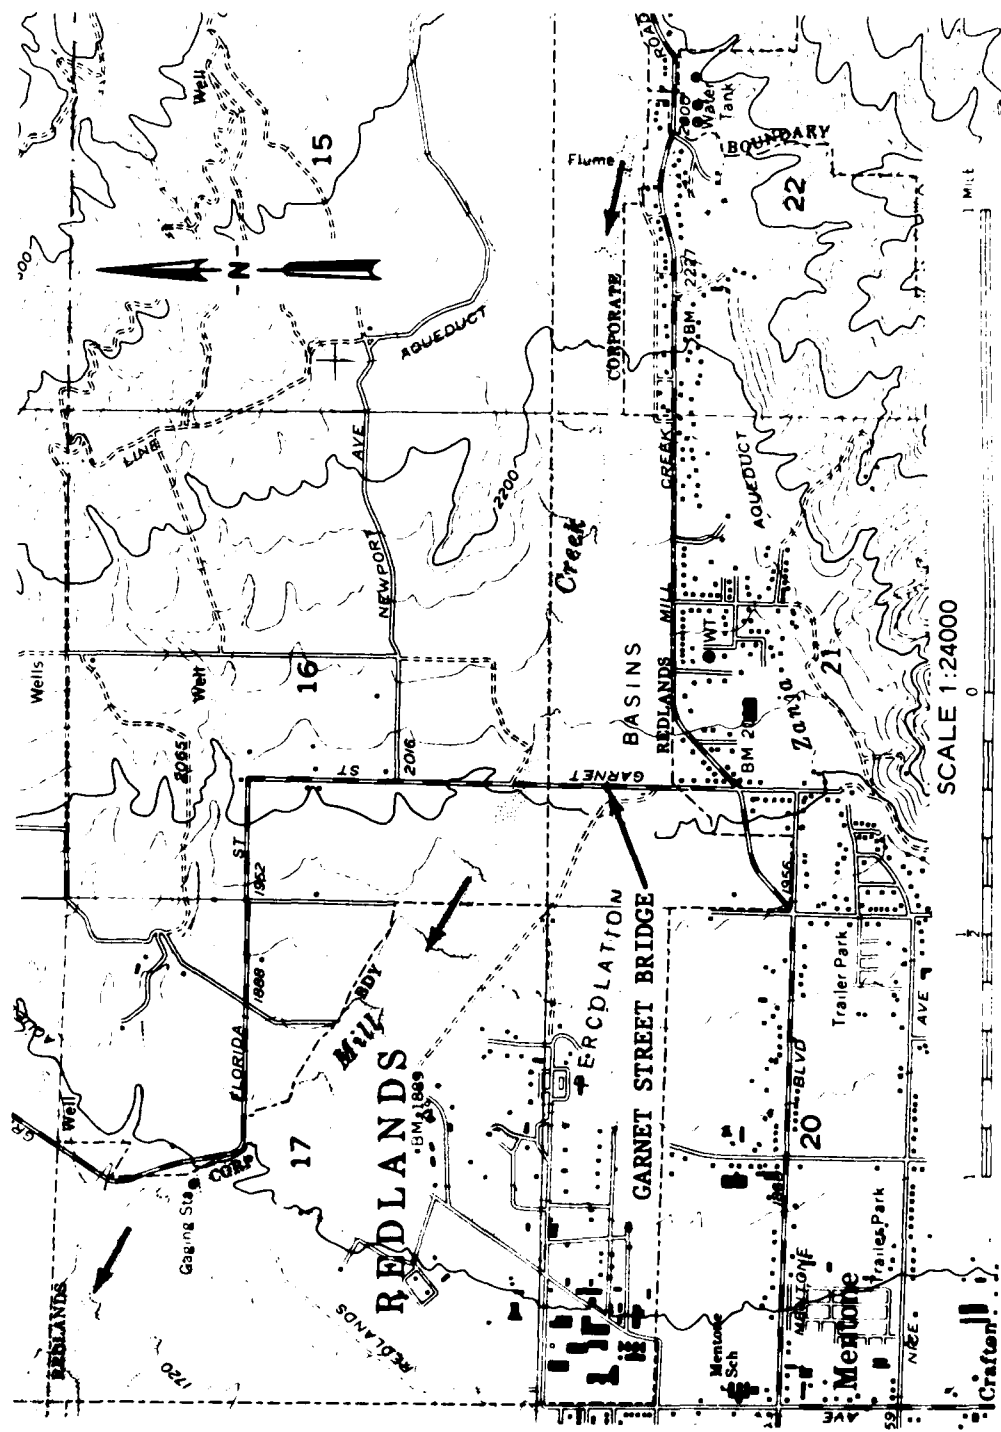
Figure 1. Mill Creek near Mentone, Calif. (Source: USGS 1:24,000 topographic quadrangle map for Yucaipa, Calif., 1967) (photo revised 1973)

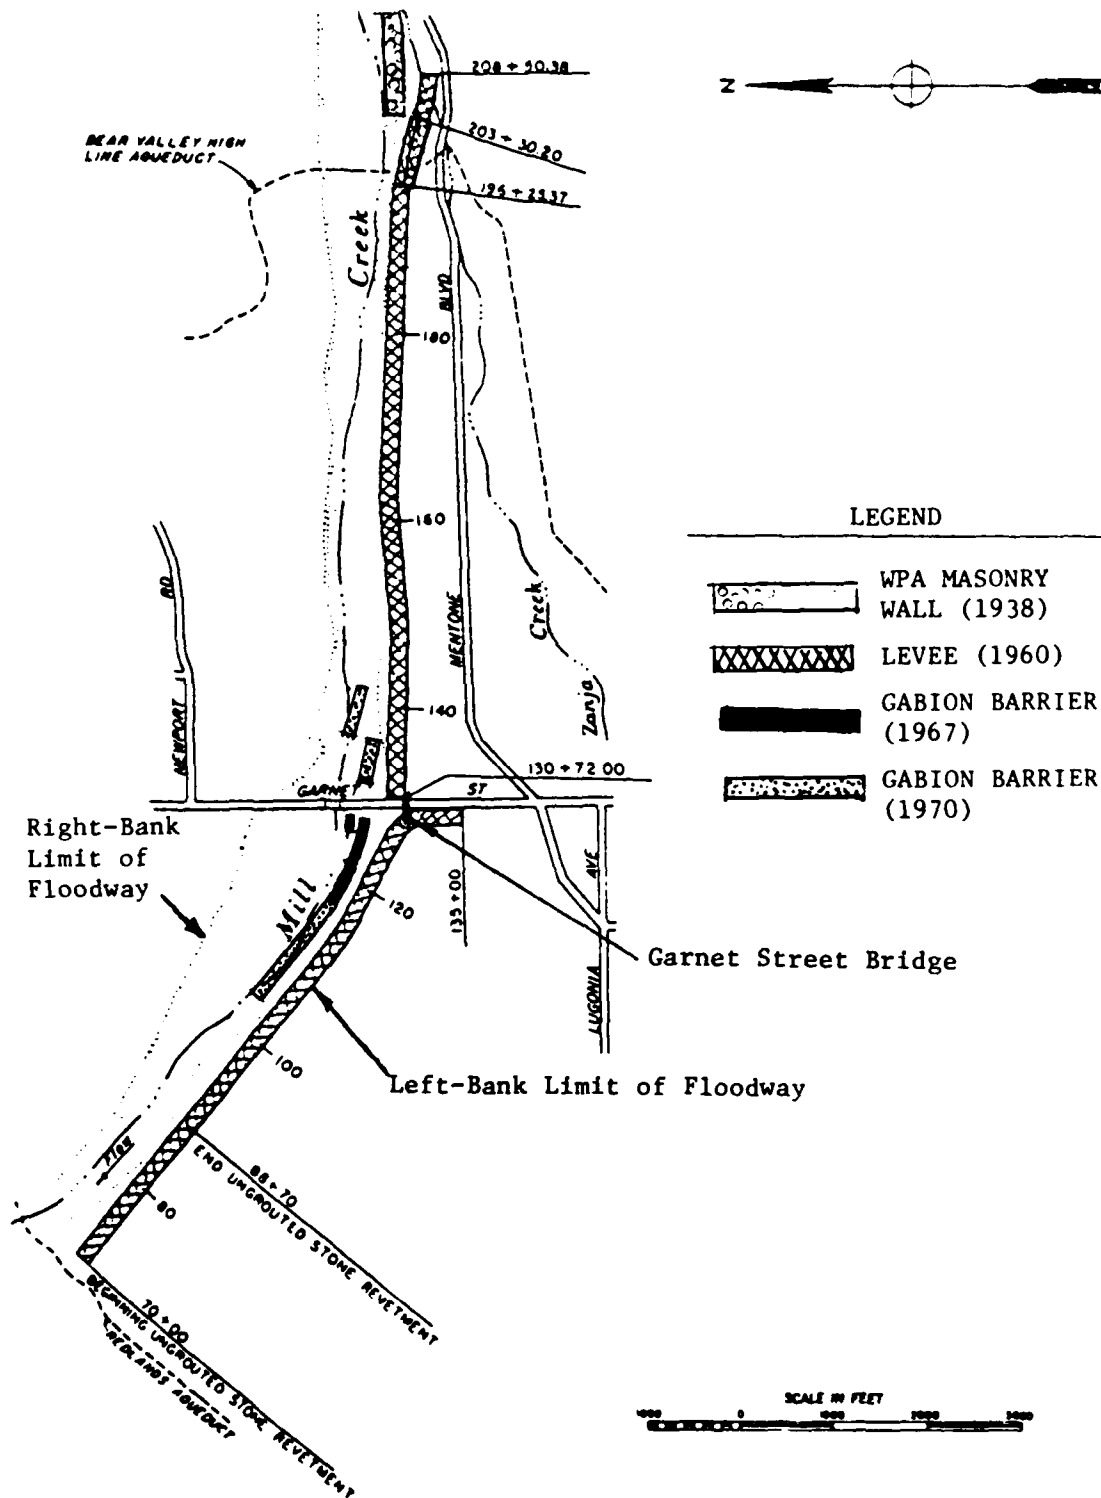
Figure 3. Limits of Mill Creek floodway and locations of WPA masonry wall, levee, and gabion barrier. Station numbers are referenced to 1960 project control line (adapted from Reference 1)

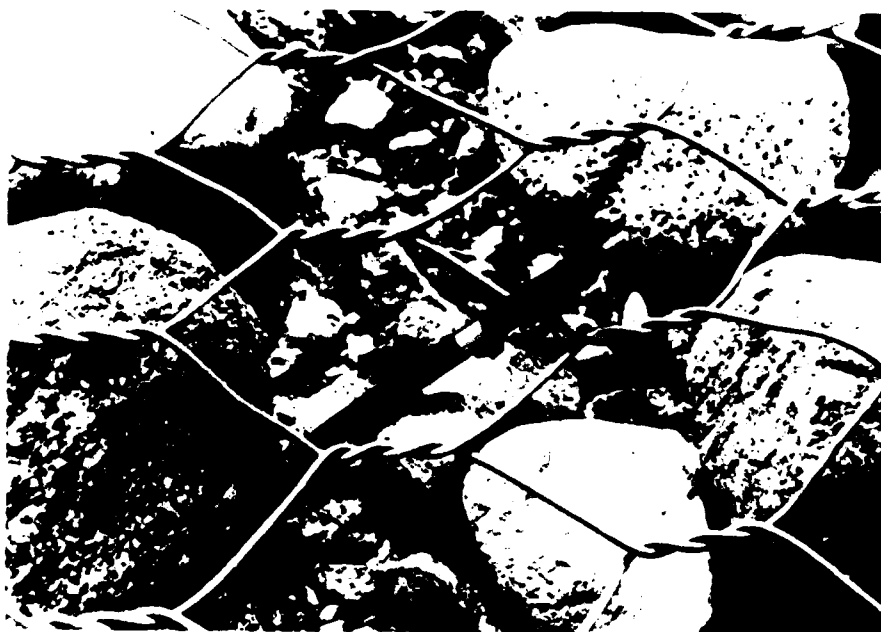
Figure 7. Detailed view showing the wire mesh structure and the variation in streambed stone sizes used to fill the gabions in Mill Creek (photograph taken 6 August 1979)

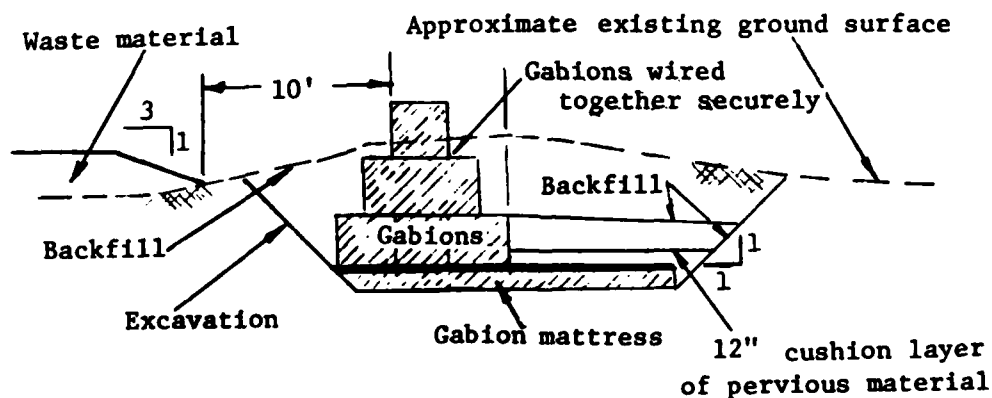
14. The principal feature of the 1967 project consisted of a two-part midfloodway gabion barrier, about 1,500 ft long, beginning just downstream from Garnet Street Bridge (Figure 3). This structure was designed to prevent development of the cross-channel flow that caused the destruction of the sloping, ungrouted-stone face of the project levee (paragraph 12). Bekaert gabions manufactured and supplied by Terra Aqua Conservation of Reno, Nev. (a division of Bekaert Steel Wire Corp.) were filled with stone from the streambed of Mill Creek. Figure 7 shows a detailed view of the gabion wire mesh and the variation in stone sizes used to fill the gabions. Cost (1967) of the gabion barrier was \$34,000. Figure 8 shows a photograph and a cross-sectional view of the

a. Photograph taken in 1967

b. Cross-sectional view

Figure 8. Photograph and cross-sectional view of midfloodway gabion barrier downstream from Garnet Street Bridge under construction after the 1966 flood

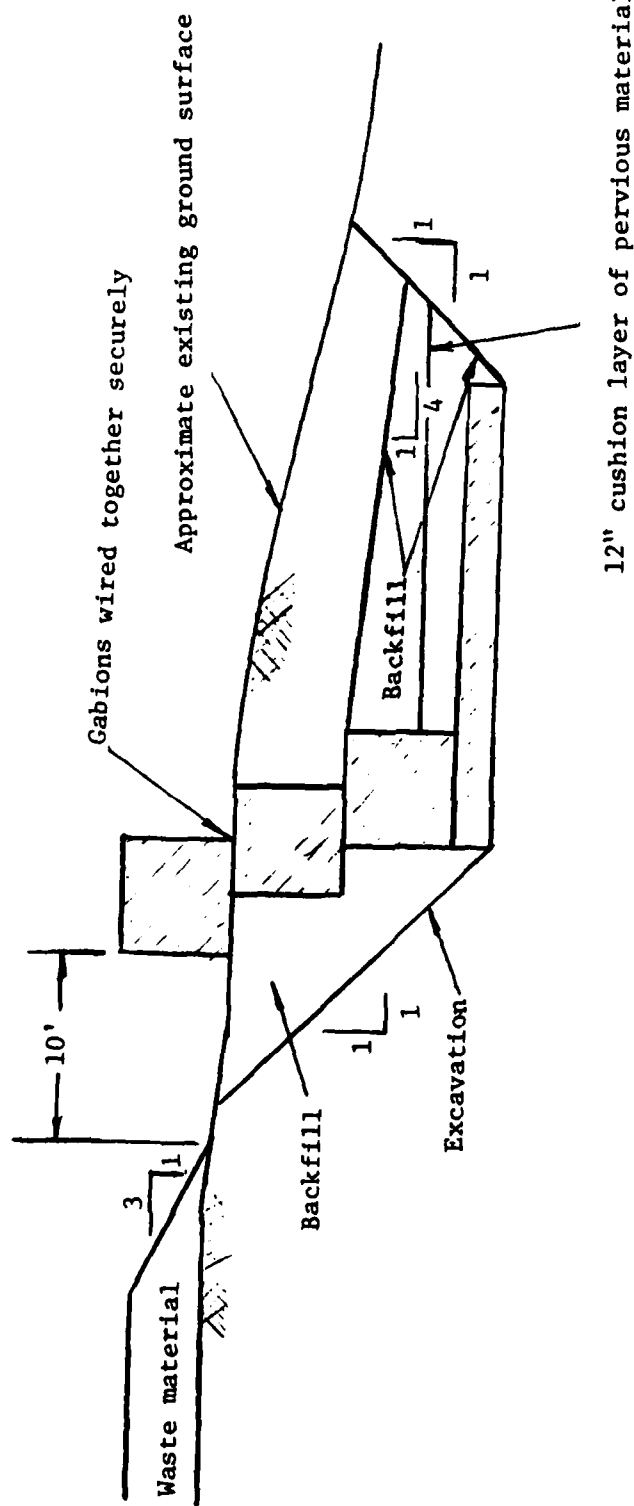
Figure 12. Cross-sectional view of midfloodway gabion barrier placed upstream from Garnet Street Bridge after 1969 floods

19. In 1970 the foundation of the gabion barrier downstream from Garnet Street Bridge was modified (as shown in Figure 11). Additionally, two new sections of the gabion barrier were placed immediately upstream from Garnet Street Bridge to divert flows away from the levees and under the bridge. The locations of these upstream gabions and a cross-sectional view are shown in Figures 3 and 12, respectively. The farthest upstream section is 675 ft long, and the section located 300 ft upstream from Garnet Street Bridge is 500 ft long. The cost (1970) of modification to the existing gabions and construction of the new section of the barrier upstream from the bridge was \$79,000.
